Beware the “Orphaned” Water Heater

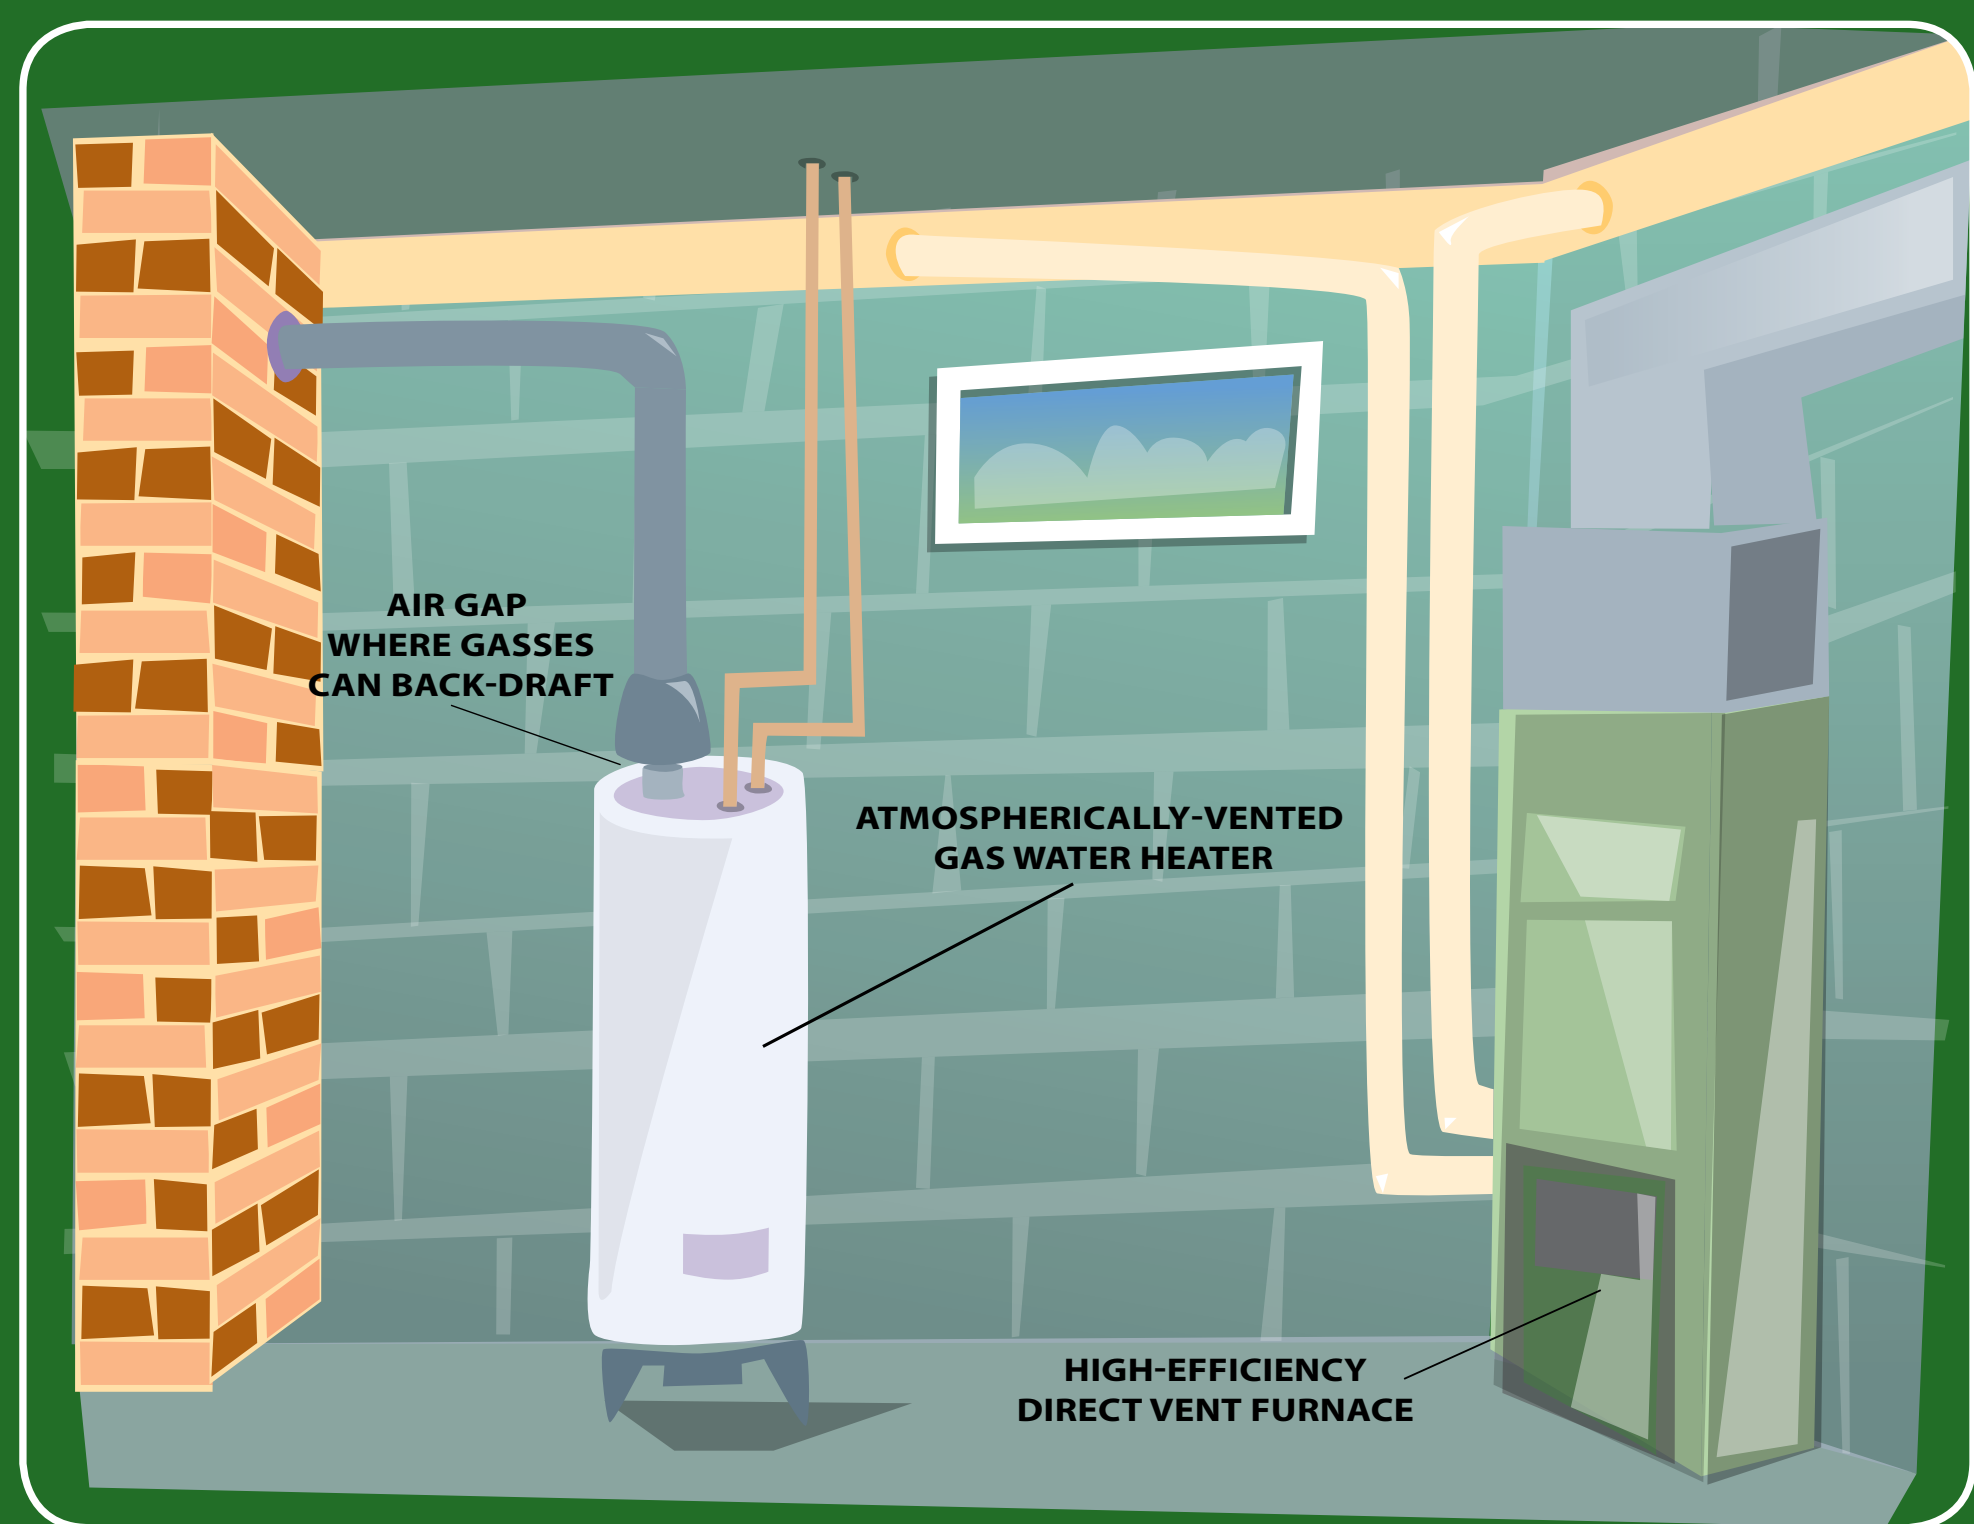
- When replacing a boiler, the most energy-efficient water heating option is an indirect tank and coil, also called a “sidearm” (displayed in this building).
- If you decide to retain the existing water heater, the chimney flue may need to be outfitted with a smaller-diameter liner. A “worst case” spillage test (part of an energy audit) should be done on the existing water heater to determine if it can safely be vented via the existing chimney.
